Exchange criteria for EUR box pallets in the European pallet pool

EUROPEAN PALLET ASSOCIATION (EPAL)

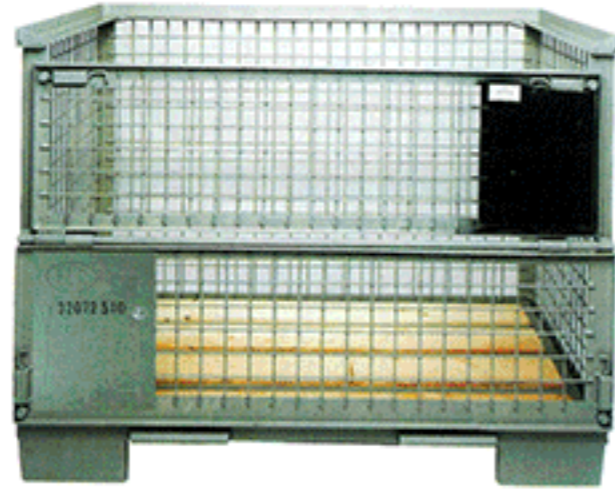
This is what an exchangeable EUR box pallet looks like.

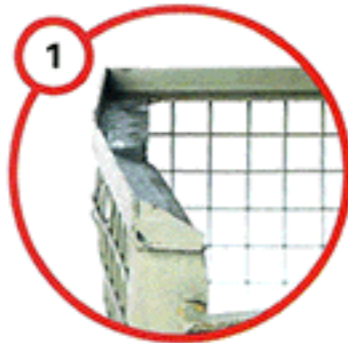
The stacking frame or the corner uprights are deformed.

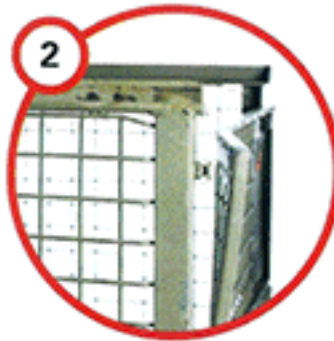
The hinged front panels can no longer be opened or closed.

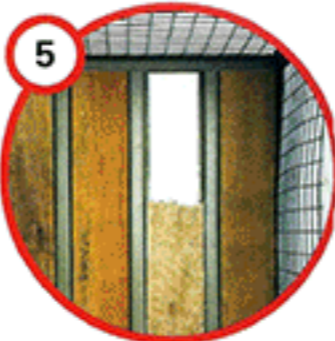
One board is missing or is broken.

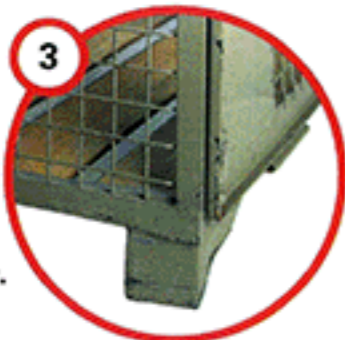
The floor frame or feet are so bent that the box pallet no longer stands firmly on four feet or can no longer be stacked safely.

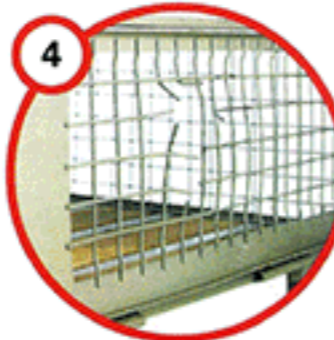
The lattice is so torn that the wire ends protrude inside or outside (one wire per wall is allowed to be missing.)

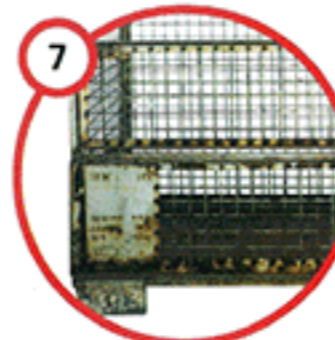
Due to rust or dirt, the general condition is so bad that freight can be contaminated.

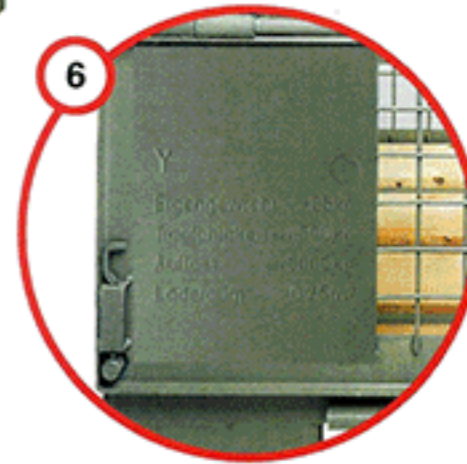
The essential identification markings are missing (EUR, railway symbol and Y number.)
